► External Leakage Due to Plate Deterioration

- Application : Brine Heater
- Operating Period : Approximately 18 years
- Operating Fluids : Steam / Salt water
- Operating Temperature :
Steam side: 127 °C / Brine side: 70 °C
- Plate Material : Pd-Ti

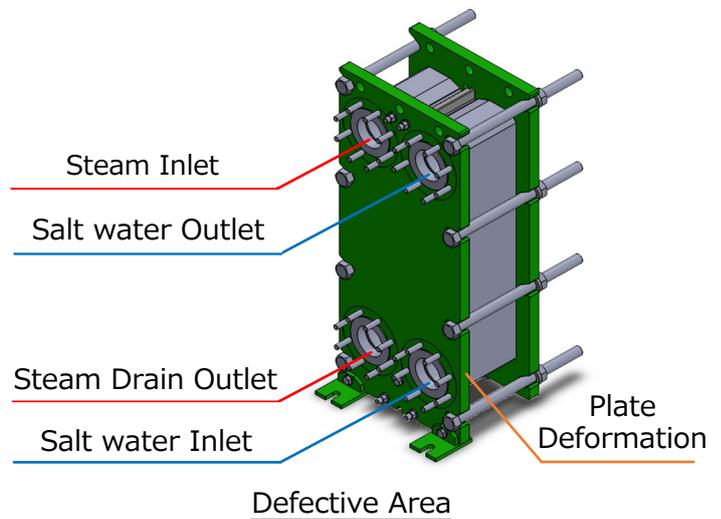
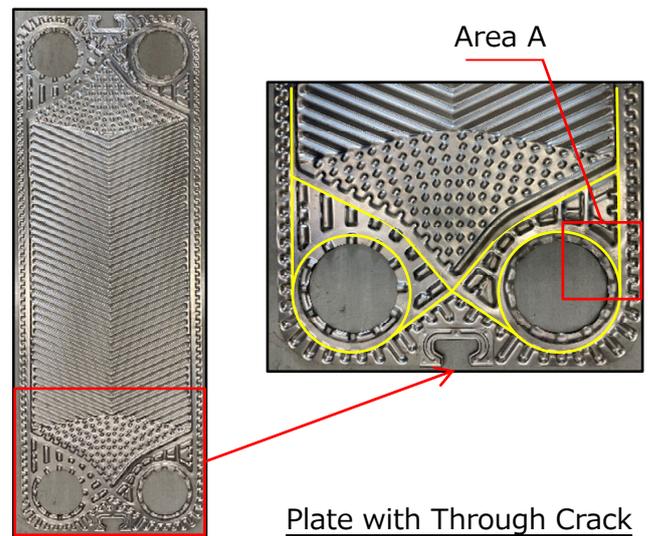
External leakage of brine was observed from the area between the S-frame and the D-plate. In addition, corrosion and wall thinning of the inner surface of the S-frame were confirmed as a result of the brine leakage.

When the same plates are used for an extended period of time, slight plate deformation—difficult to detect by visual inspection—can gradually accumulate due to repeated tightening and disassembly operations as well as gasket aging. As a result, even after replacing the gaskets with new ones, sealing performance may deteriorate due to plate deformation, leading to external leakage.

Plate Deformation Area
(approx. 3 mm deviation from
the reference plane)

Reference Plane

Luminance
Distribution Image
of Area A

It is recommended to periodically replace the plates in addition to gasket replacement. Regarding the appropriate timing for plate replacement, we can assess the condition of the plates and determine their suitability for continued use upon request for an inspection of the plate condition.
