► Erosion Due to Foreign Object Contamination

- Application : Circulating Water Cooler
- Operating Period : Approximately 2 months
- Operating Fluids :
Circulating water / Cooling water
- Operating Temperature :
Circulating water side: 35°C
Cooling water side: 34 °C
- Plate Material : Type 316 Stainless Steel

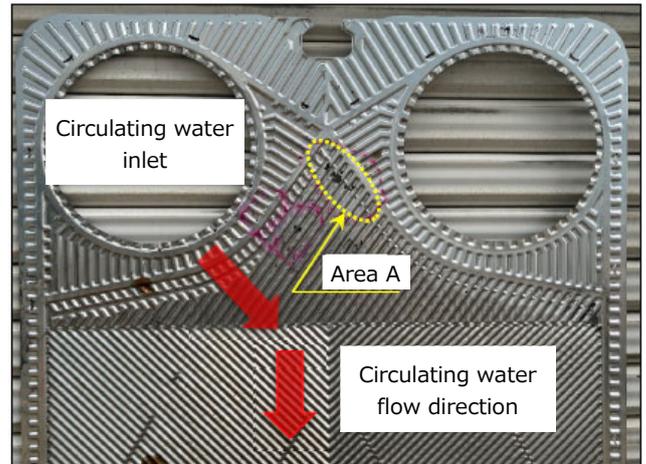
Overall View of the Plate

The plates developed through cracks, resulting in mixing of the two fluids.

Erosion occurred near the plate inlet due to silica sand contained in the circulating water, which led to through-thickness cracking of the plates.

Therefore, countermeasures such as installing a strainer to prevent foreign matter from entering the
