Plate Heat Exchanger

GUIDE HISAKA Plate Heat Exchanger Maintenance Guide

HISAKA WORKS, LTD.
Heat Exchanger Division

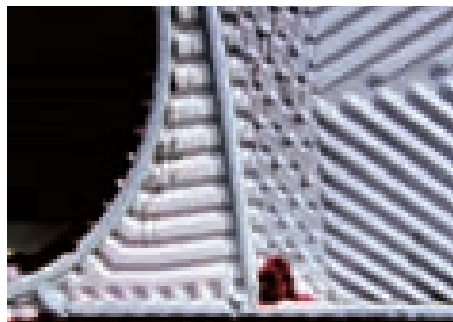
↑ Cracking visual inspection (top)
Cracking detection by dye penetration test (bottom)

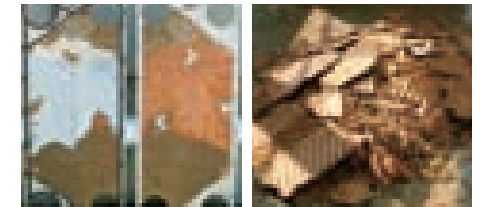
↑ Hard scale inside the plates

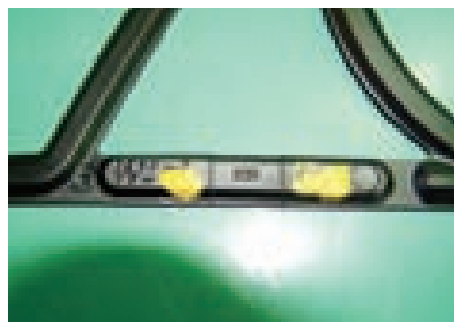
↑ With the lot number and yellow marking, it can be confirmed that this material is NBR.

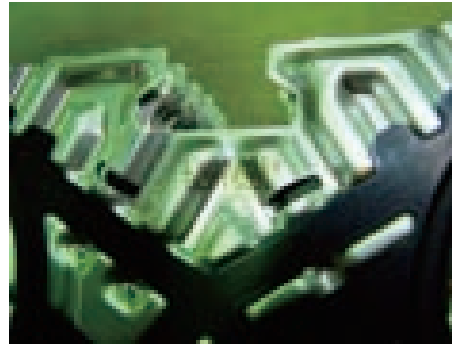
↑ Lot number
Indicates that model LX-026, S316 is made of SUS316.

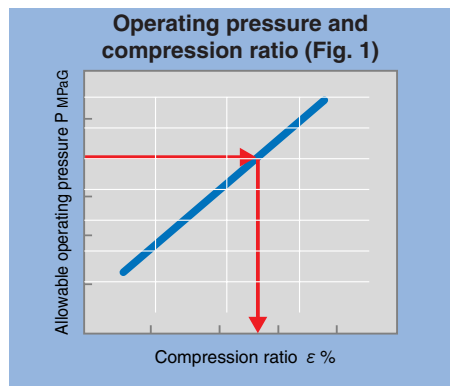
When using this relationship, it is possible to predict the minimum compression free gasket thickness t_0 [mm] that will be required at the allowable operating pressure. \dots (Fig. 1)

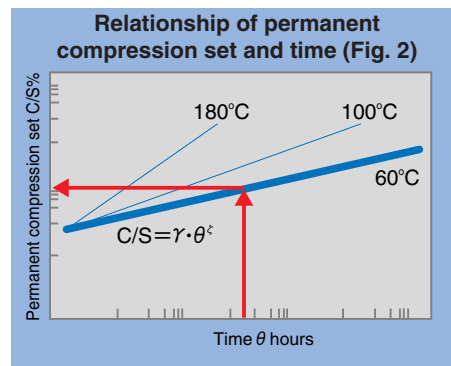
From this relationship, it will be possible to predict the gasket thickness t_1 [mm] after a certain amount of time has passed. \dots (Fig. 2)

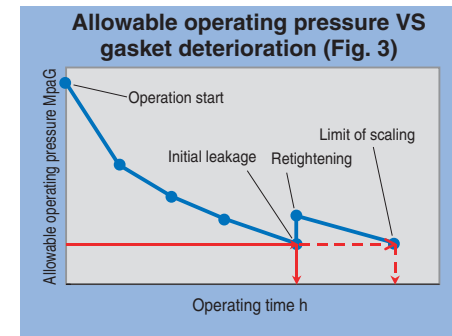
Using this relationship, Fig. 3 shows the relationship between operating time and allowable operating pressure. When the permanent compression set of the gasket increases from operation start, and the allowable operating pressure goes down below the operating pressure, the initial leakage will occur. By retightening thereafter, the compression ratio of the gasket will be revived and it will be usable again, but when the permanent compression set increases further, the gasket will reach the limit of sealing and it will need to be replaced.

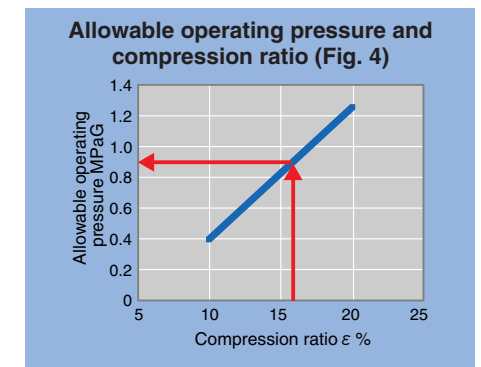
From Fig. 4, the allowable operating pressure 0.92 [MPa] > operating pressure 0.5 [MPa]. From ①~④ here, this gasket is possible to use.

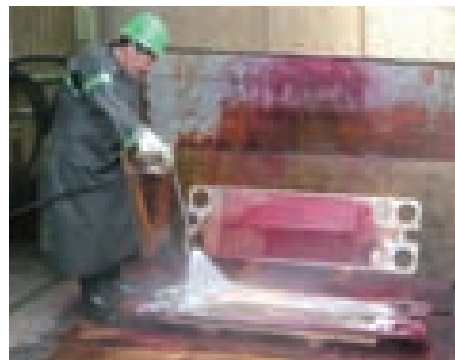
Remove the gasket from the plates, and clean with a deck brush, or water jet. In a case of water jet, to avoid deformation of the plate and damage to sealing surfaces, set on a flat panel and a reinforcement panel, and the water jet should be from a distance of 200mm or more.

↑ Water jet

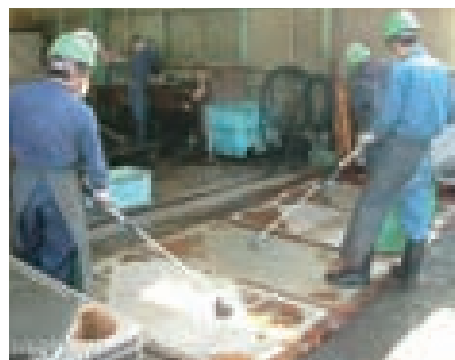
↑ Brush cleaning

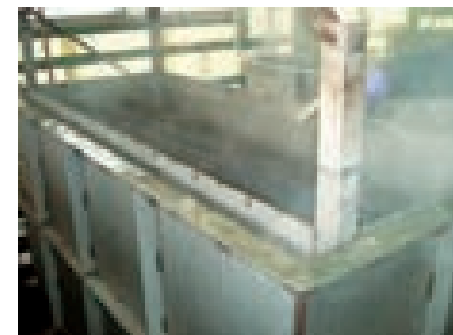
Soaking... The plates are soaked in a chemical bath. In this case, it is necessary to control the process, being very careful of the chemical temperature, concentration and washing time so that the plates are not corroded by the chemicals.

↑ Soaking in a chemical bath to remove hard scale.

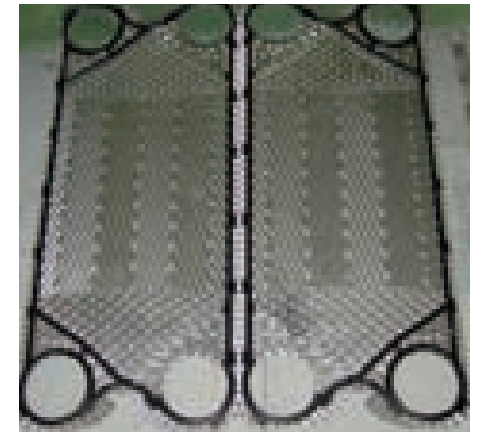
↑ Plates after cleaning

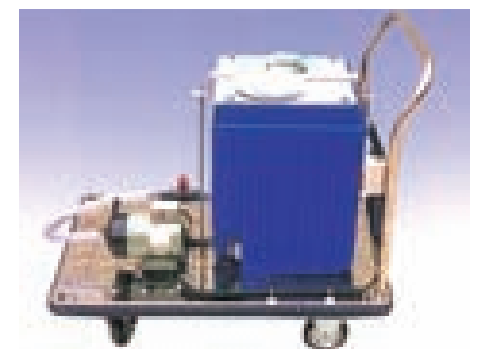
Cleaning-in-place (CIP)... After washing through the heat exchanger by hot water with a higher flow rate than designed, a chemical (acid, alkali) is circulated for chemical cleaning. After chemical cleaning, rinse thoroughly with fresh water not to remain a chemical residue.

↑ Cleaning-in-place (CIP) Unit...A simple mobile CIP unit with caster wheels, and CIP cleaning for plate heat exchangers without disassembly.

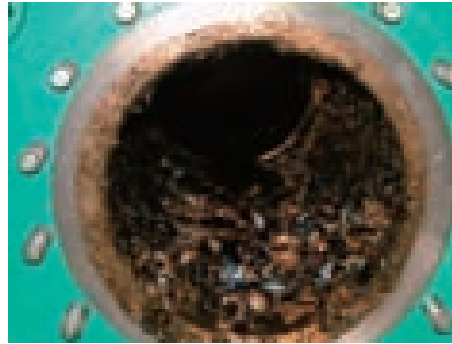
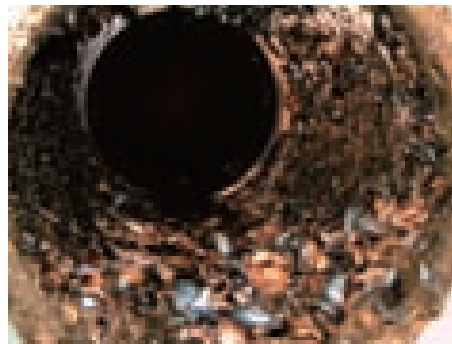
↑ **Heat exchanger Seawater inlet port hole**
Wood chips, seaweeds and shellfish are blocking the flow channel, and causing poor flow in the unit.

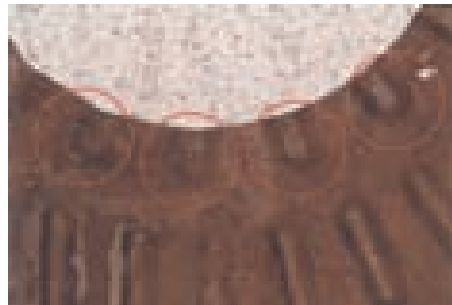
- Operating time...Approx. 8 years
- Plate material...SUS316 (Stainless Steel 316)
- Duty...Chromium acid plating fluid/ cooling water
- Operating temperature...30°C
- Cause...Plate material is less corrosion resistance.
- Action and correction...After 8 years operation without fault, and is still possible to operate. But, it is necessary to increase the plate thickness, or change the material to titanium which is fully corrosion resistant, etc. A guideline of corrosion rate for material selection should be less than 0.1 mm/y.

↑ Magnified of the port hole of plating fluid side

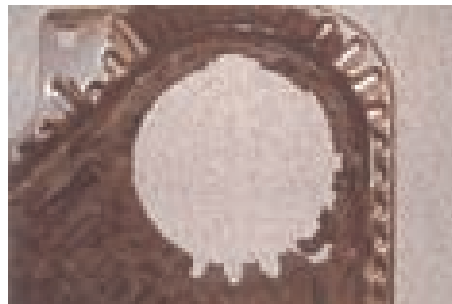
↑ Port hole of plating fluid side

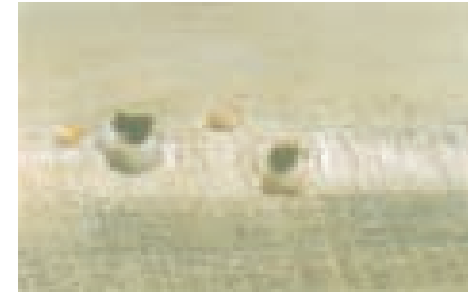
- Operating time...Approx. 1 year
- Plate material...SUS304 (Stainless Steel 304)
- Duty...Engine circulation cooling water/ cooling water
- Operating temperature...90°C
- Cause...The Cl^- ion concentration in the circulating fluid was 50ppm which is not a concentration that would be corroded, but localized concentration of Cl^- between deposit of scale and plate surface causes pitting corrosion.
- Action and correction...It is necessary to grade up the steel grade to SUS316, etc., with increased Cr, and Mo added. Also, periodic disassembly inspection and regeneration of the passive film through scale removal, and water quality control for the fluid, are recommended.

↑ Magnified of the corroded area

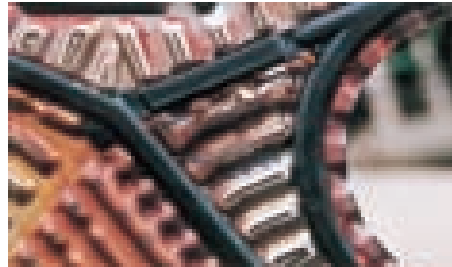
- Operating time...Approx. 5 years
- Plate material...SUS304 (Stainless Steel 304)
- Duty...Steam / city water
- Operating temperature...140°C
- Phenomenon...A tiny leak from the shoulder area of the plate on the steam side by deterioration of the gasket entered the double seal area of the plate, and with the concentration of Cl^- ions which are factors of corrosion, corrosion attacks penetrated the plate. Consequently, the city water leaked from the double seal area of plate.
- Cause...This is a pitting corrosion due to concentration of Cl^- ions, caused by leaving the tiny leakage from the steam side.
- Action and correction...Replace the gasket periodically, and change to higher grade plate material like SUS316, etc.

↑ Stress cracking (later noted) also occurred under rust deposit

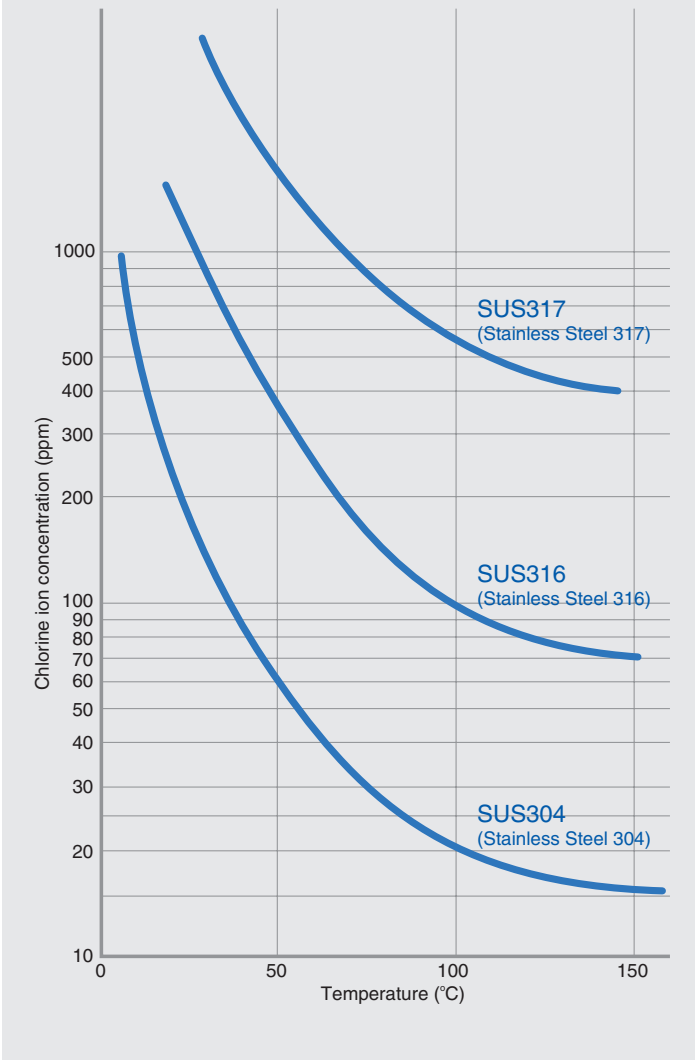
Guideline curve for risk of crevice corrosion for stainless steel

Crevice corrosion resistance of stainless steel

The main factor of crevice corrosion and pitting corrosion in austenite stainless steel, is the concentration of Cl⁻ (chlorine ions) in water. If the Cl⁻ concentration in the fluid is known, please refer to this curve to select the material.
 Example) For cooling water where the Cl⁻ ion concentration is 100ppm or less, and the maximum temperature is 40°C. There would be a slight concern for risk of corrosion with SUS304, so SUS316 is preferable.

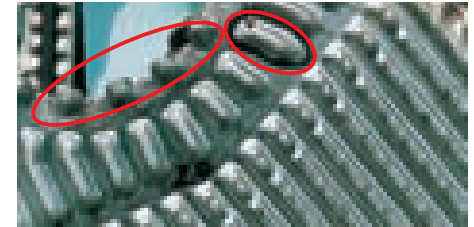
↑ Decreasing the plate thickness due to severe erosion corrosion

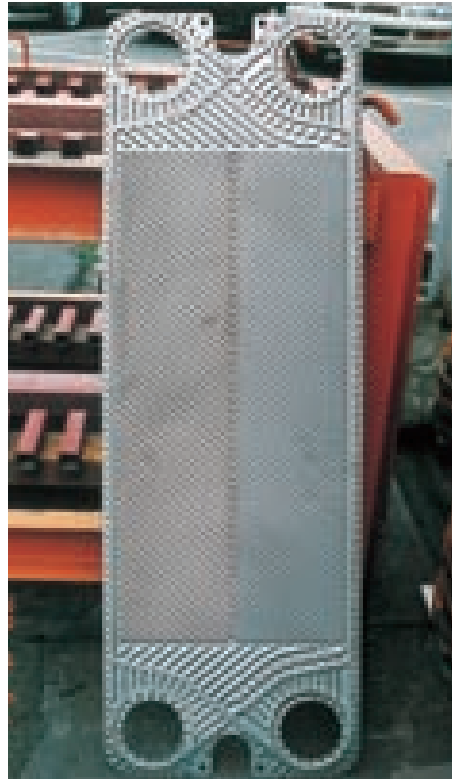
- Operating time...Approx. 2 years
- Plate material...SUS304 (Stainless Steel 304)
- Duty...Primary water / secondary water
- Operating temperature...90°C
- Phenomenon...There was an occurrence of rust deposit on the back side of the gasket, and a crack occurred at the gasket seal line.
- Cause...It is possible that when chloride ions in the fluid was exposed to high temperature conditions, it was concentrated at gasket areas where the flow rate is slow, and the plate was corroded here rapidly. The crack can be determined to be stress corrosion cracking due to the rust deposit occurrence and branch shape crack.
- Action and correction...Because the plate surfaces are also corroded, using SUS304 may be corroded by this water quality. We recommend to use the material to the molybdenum added SUS316, which is anti-chloride material.

↑ Plate

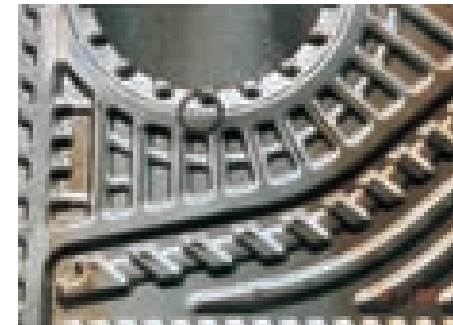
- Operating time...Approx. 3 years and 7 months
- Plate material...TP270 (Titanium 270)
- Duty...Mixed organic vapors / ethylene glycol solution
- Operating temperature...99°C
- Phenomenon...A crack occurred on the plate, and leakage was found.
- Cause...Used as a condenser for mixed organic vapors (toluene, methanol, acetone, etc.). It is supposed that a crack occurred due to the methanol in the vapors, and stress corrosion cracking occurred.
- Action and correction...Austenite type stainless steel is suited for methanol existing circumstance. We recommend changing material to the type to SUS316.

↑ Magnified of the vapor side

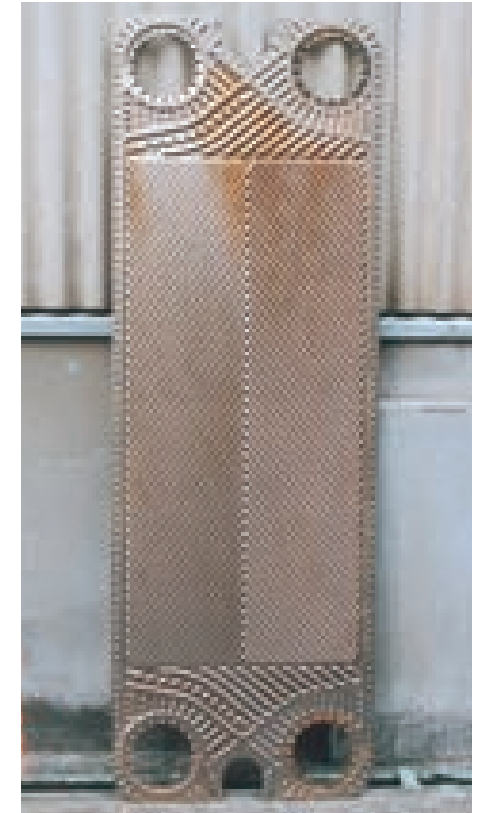
↑ Vapor side

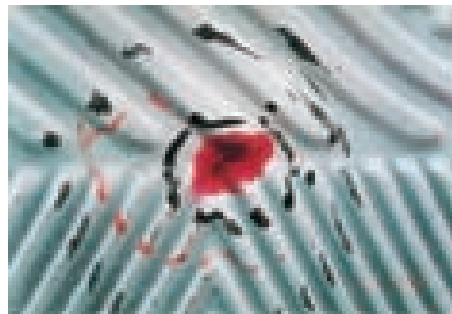
- Operating time...Approx. 13 years and 8 months
- Plate material...SUS316 (Stainless Steel 316)
- Duty...Steam / thermo oil
- Operating temperature...130°C
- Phenomenon...When brine instead of steam and thermo oil was periodically used through the unit alternately, a inter-mixing of brine and thermo oil occurred. In the 5 plates, a crack was found near the end of the center of the heat transfer zone, at lower part of the plate.
- Cause...Because there are no traces of corrosion on the plates, and the position of the cracks of each plate is the same, and because this is a position where stress will concentrate and the load is high, fatigue crack is concluded to be the cause.
- Action and correction...It is concluded that fatigue crack occurred because this unit was used for long years. To increase the strength of the plates, a thicker plate is recommended.

↑ Magnified of the fatigue crack
